Miscellaneous Paper SL-96-1  
February 1996

## Forced Entry Testing of Five-Minute Walls

Prepared for U.S. Department of State,  
Office of Foreign Building Operations

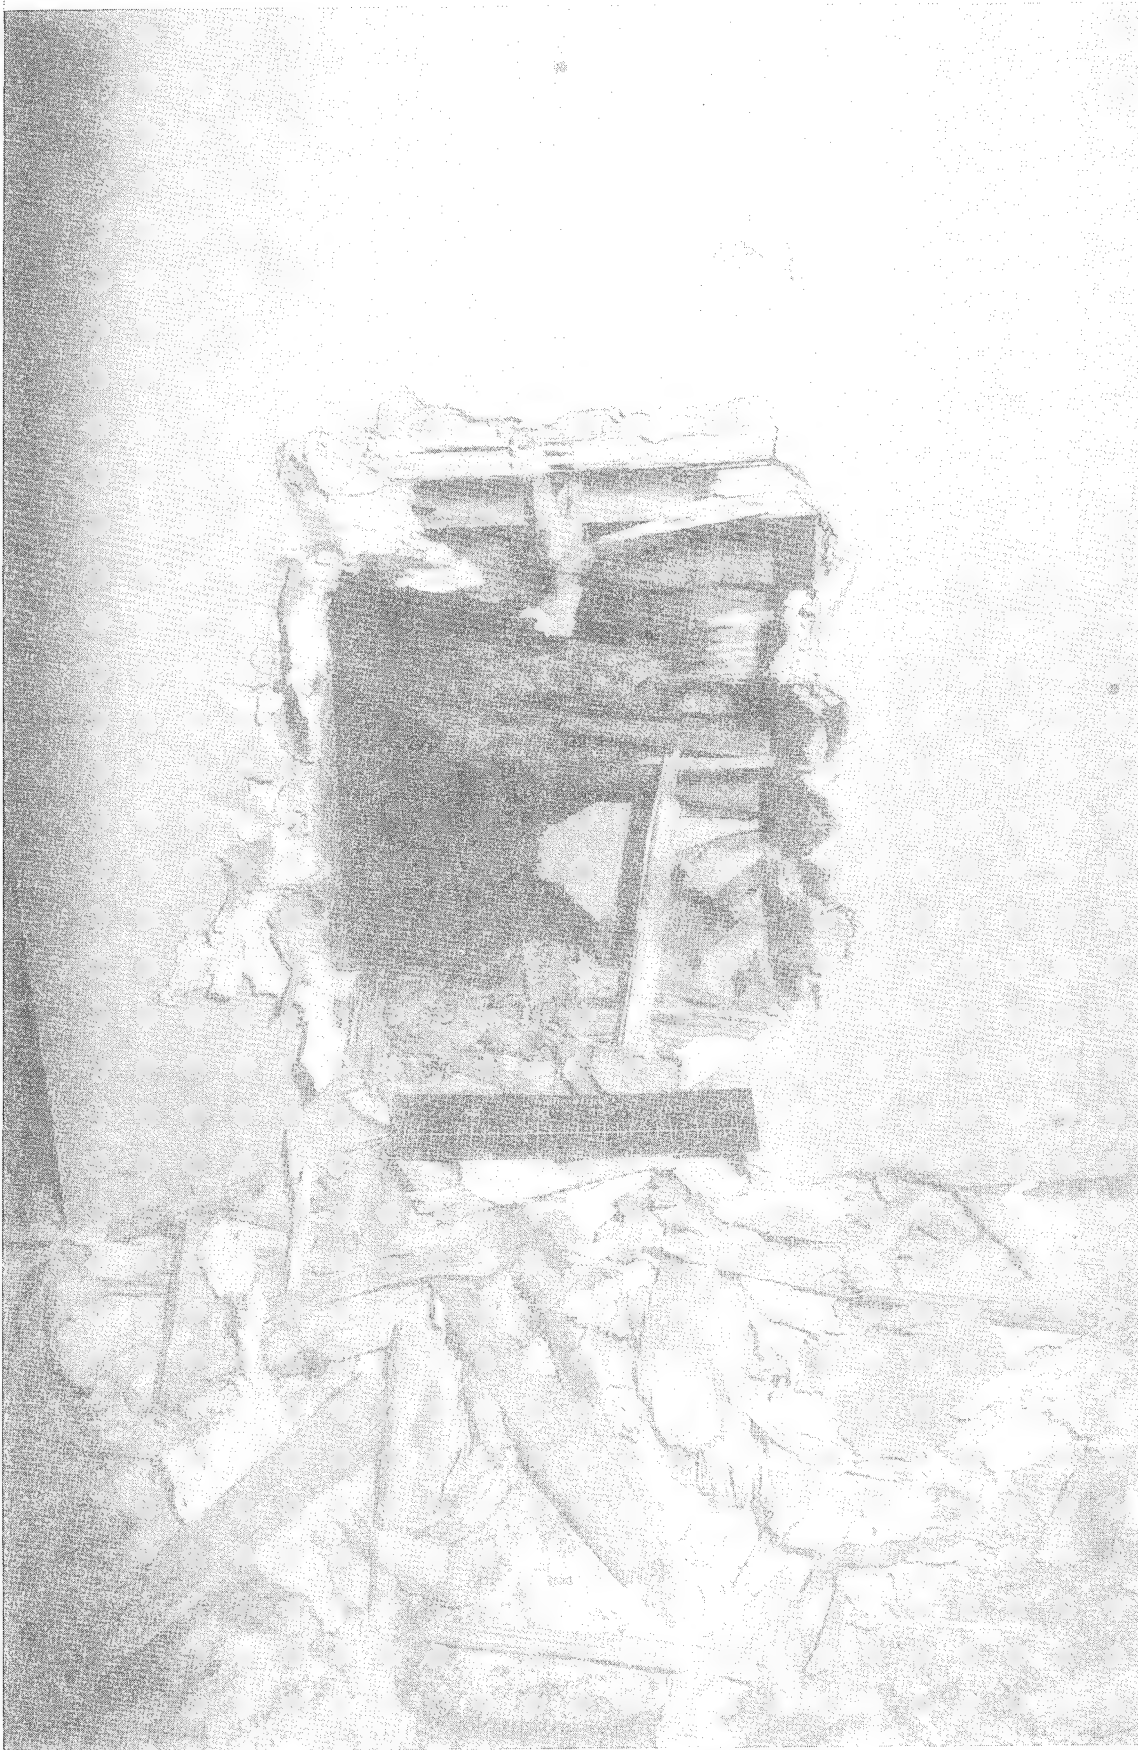
The assault began at 09:35:00 on 31 May 95. Sledgehammers, used exclusively during this assault, proved effective at shattering gypsum board and the wood used in the construction of this panel. A rotating technique was employed by the assault team, since the two right-handed hitters could not direct their swings simultaneously toward the same region of the panel. This technique involved the first man taking a single swing and then moving back so that the second man could move in and take a swing. The assault continued in this manner until the assault team pushed the metal box completely through the opening in the panel at 09:39:56. The total penetration time was 4 minutes and 56 seconds. Posttest photographs of the opening in the panel are presented in Figures 28 and 29.

Figure 28. Assault side of panel XPK-05N-DOS-01 after test 1-1

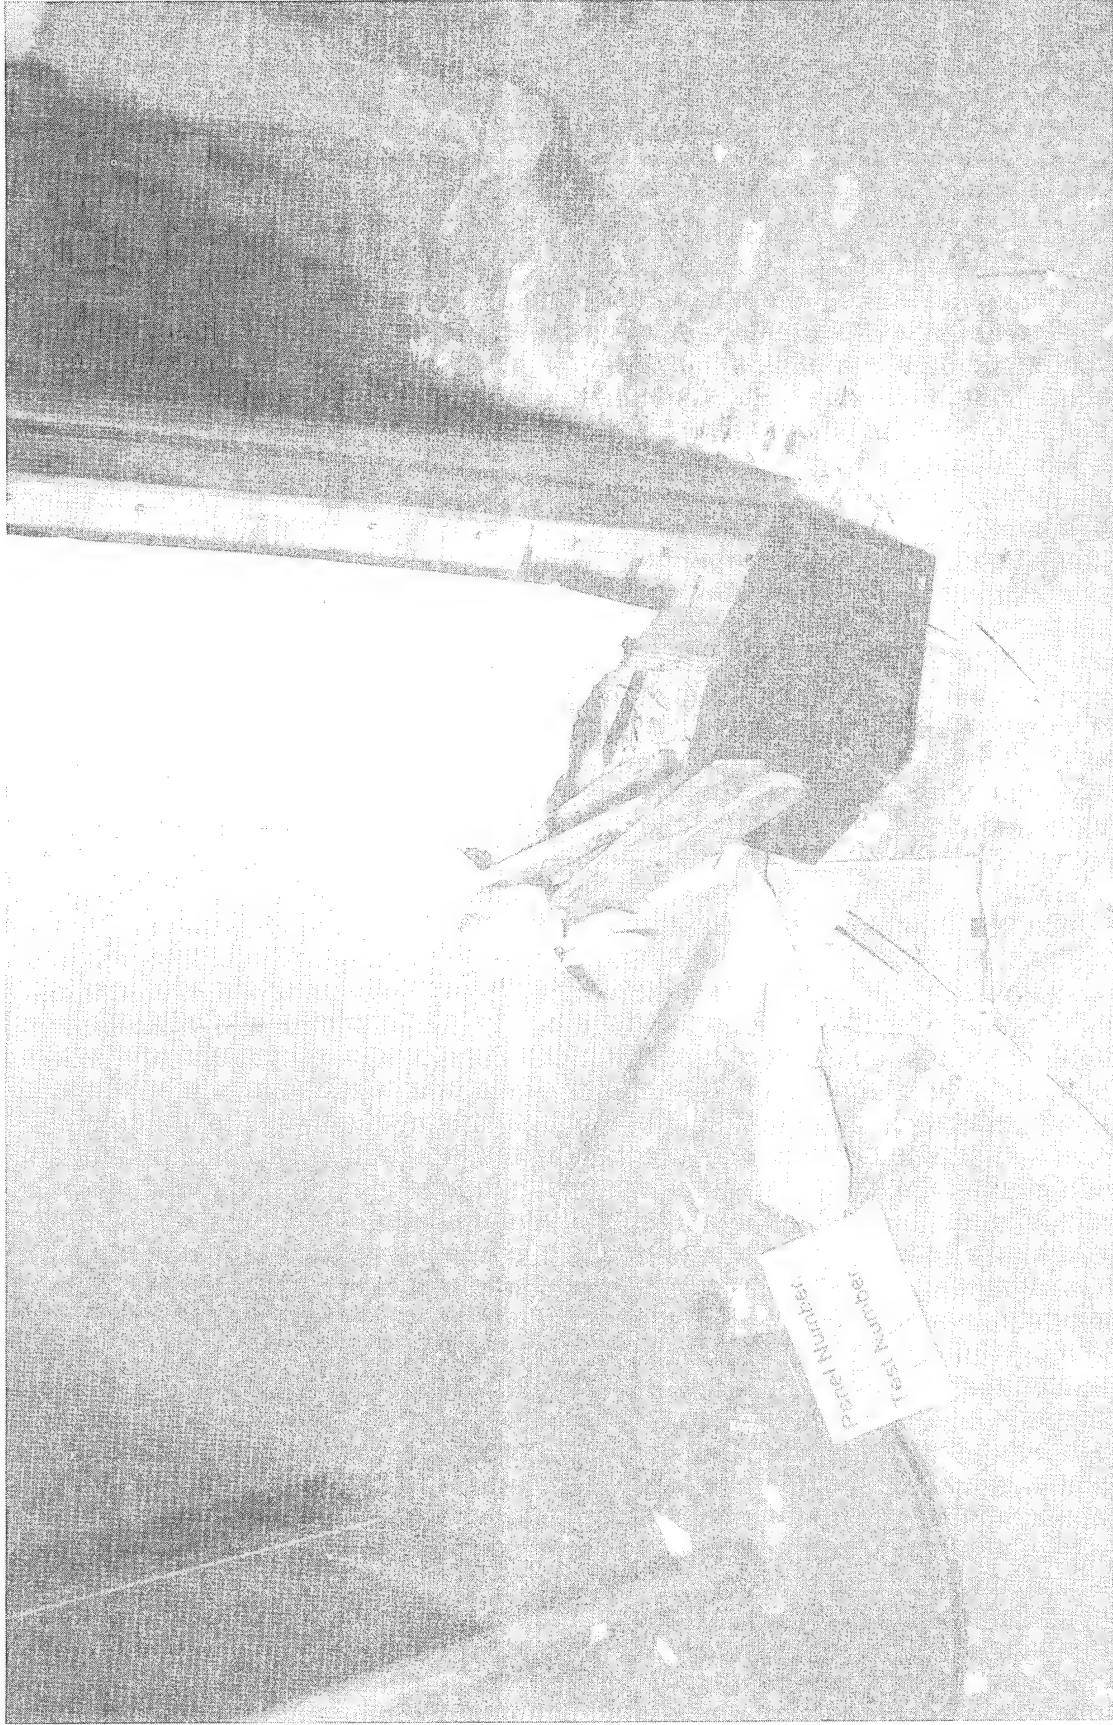
Figure 29. Protect side of panel XPK-05N-DOS-01 after test 1-1

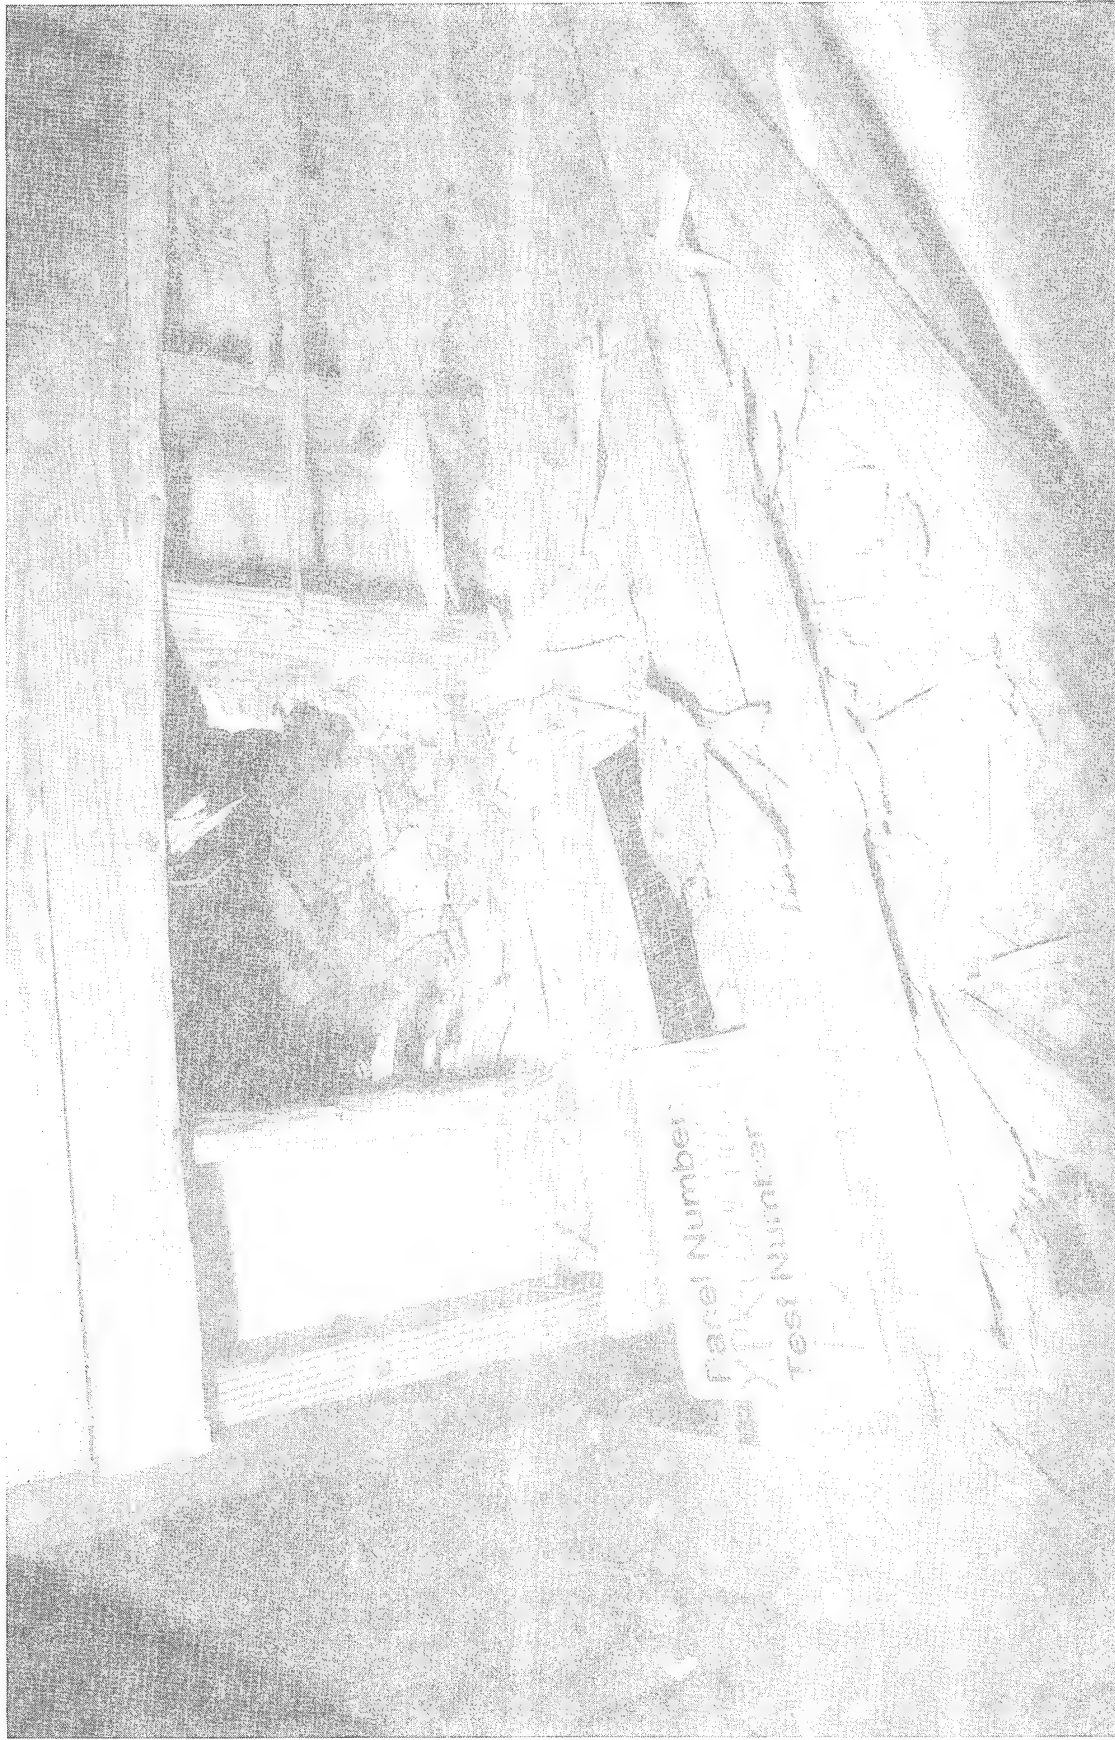
Figure 31. Protect side of panel XPK-05N-DOS-01 after test 1-2

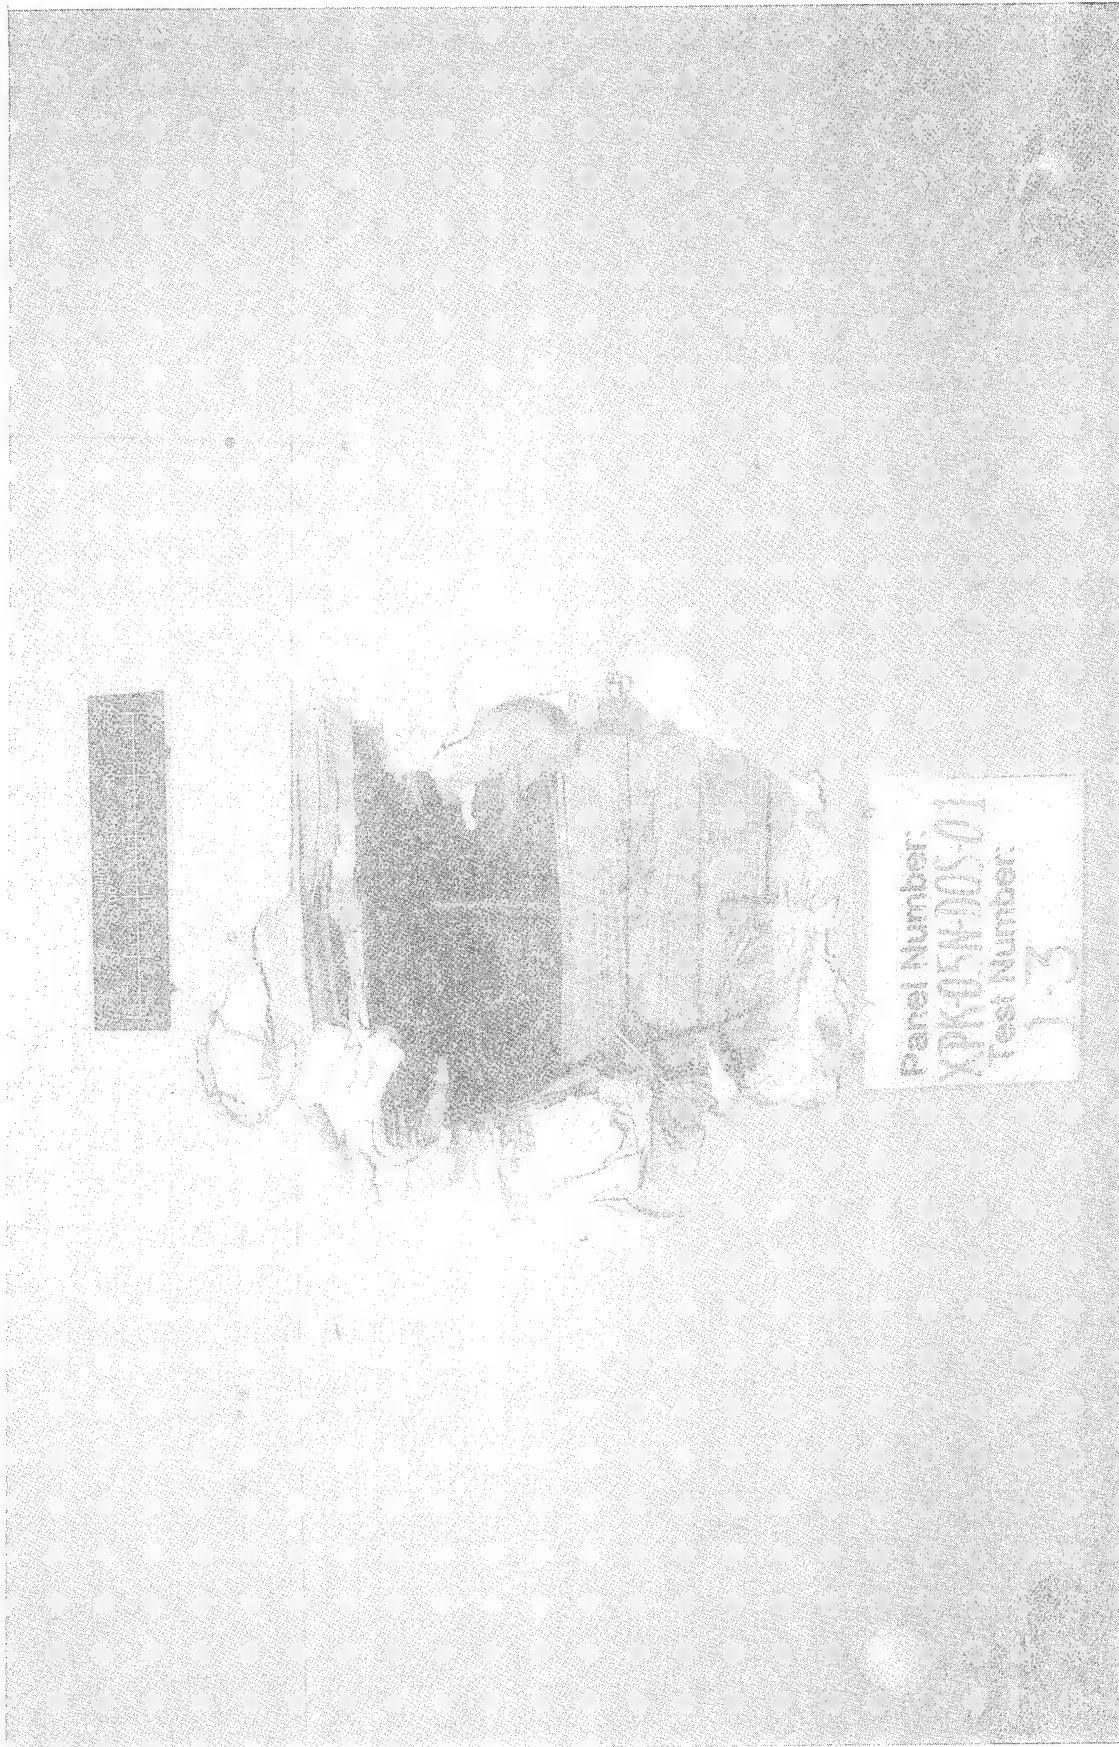
The assault began at 10:55:00 on 31 May 95 with the assault team using sledgehammers. The sledgehammer assault continued until 10:57:32 when the assault team began using the ram to break loose the wood board sheathing on the protect side of the panel. (The protect side is opposite the assault side of the panel.) After using the ram for approximately 8 seconds, the assault team returned to the sledgehammers which they used until 10:58:35 when they pushed the metal box completely through the opening in the panel. The total penetration time was 3 minutes and 35 seconds. Posttest photographs of the opening in the panel are presented in Figures 32 and 33.

Figure 32. Assault side of panel XPK-05N-DOS-01 after test 1-3

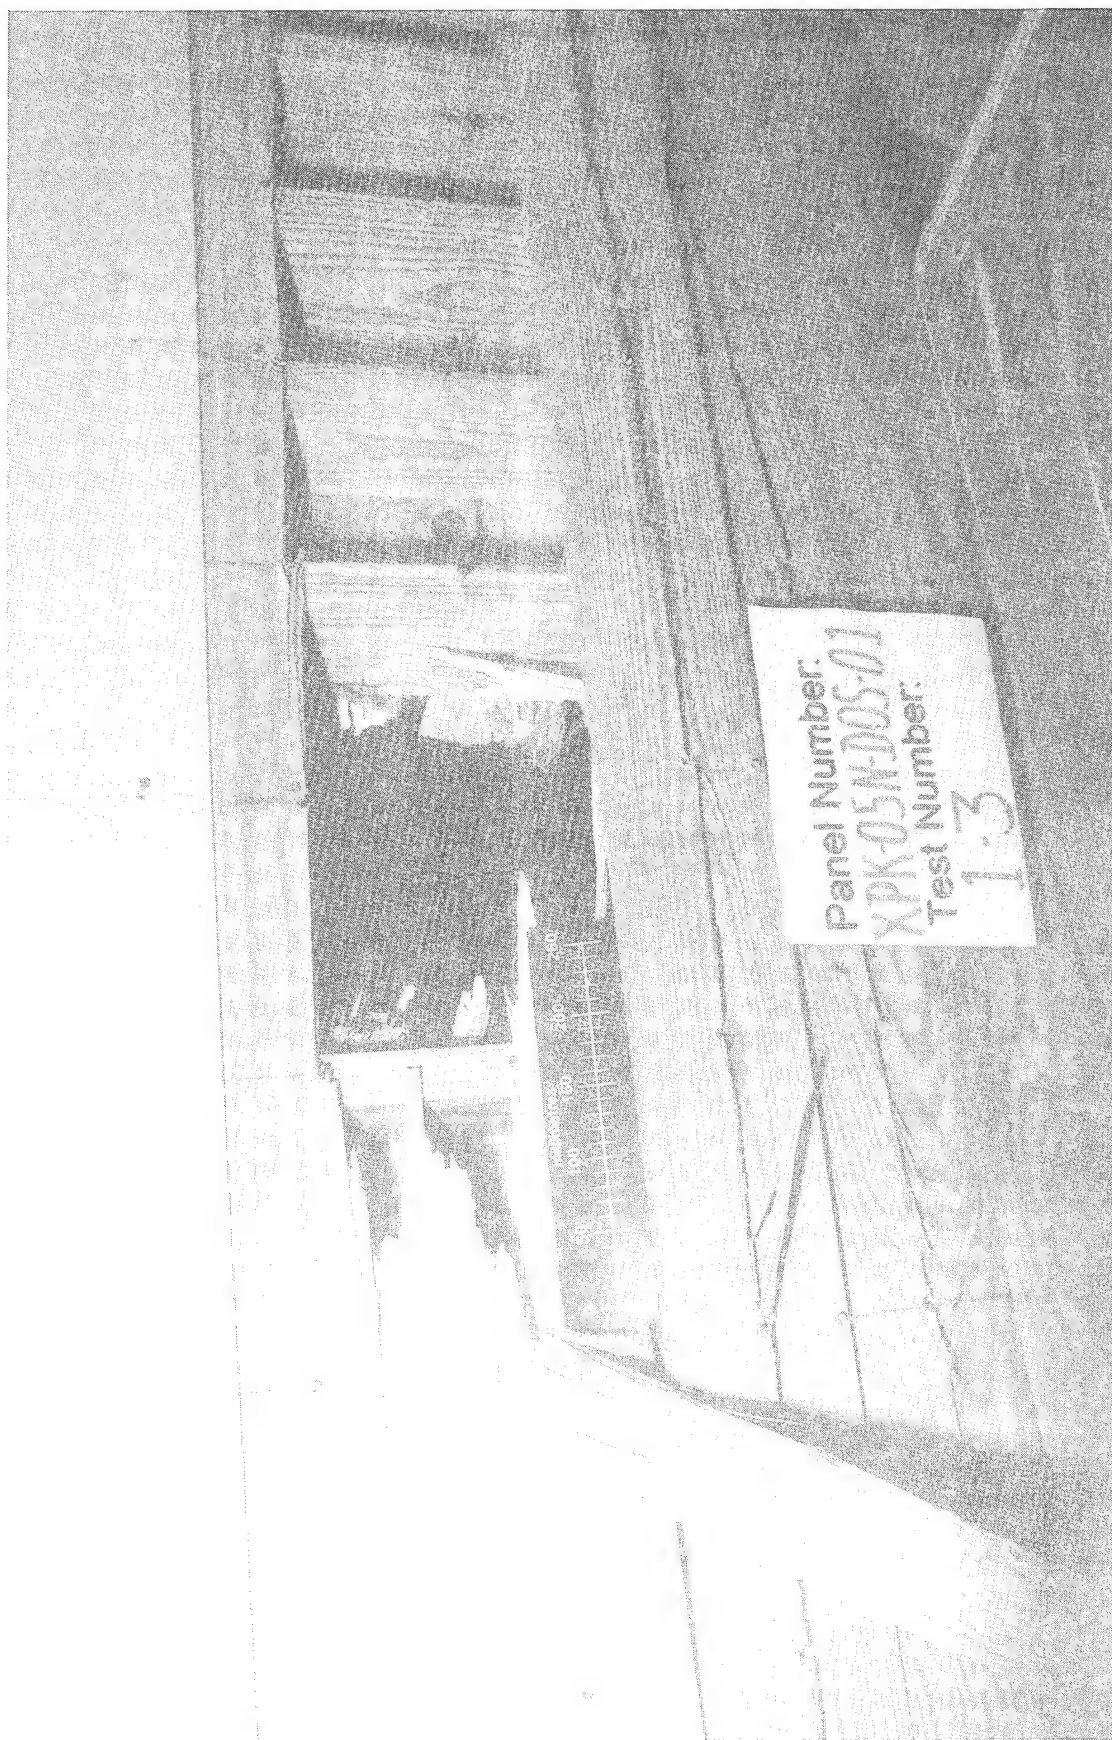
Figure 33. Protect side of panel XPK-05N-DOS-01 after test 1-3

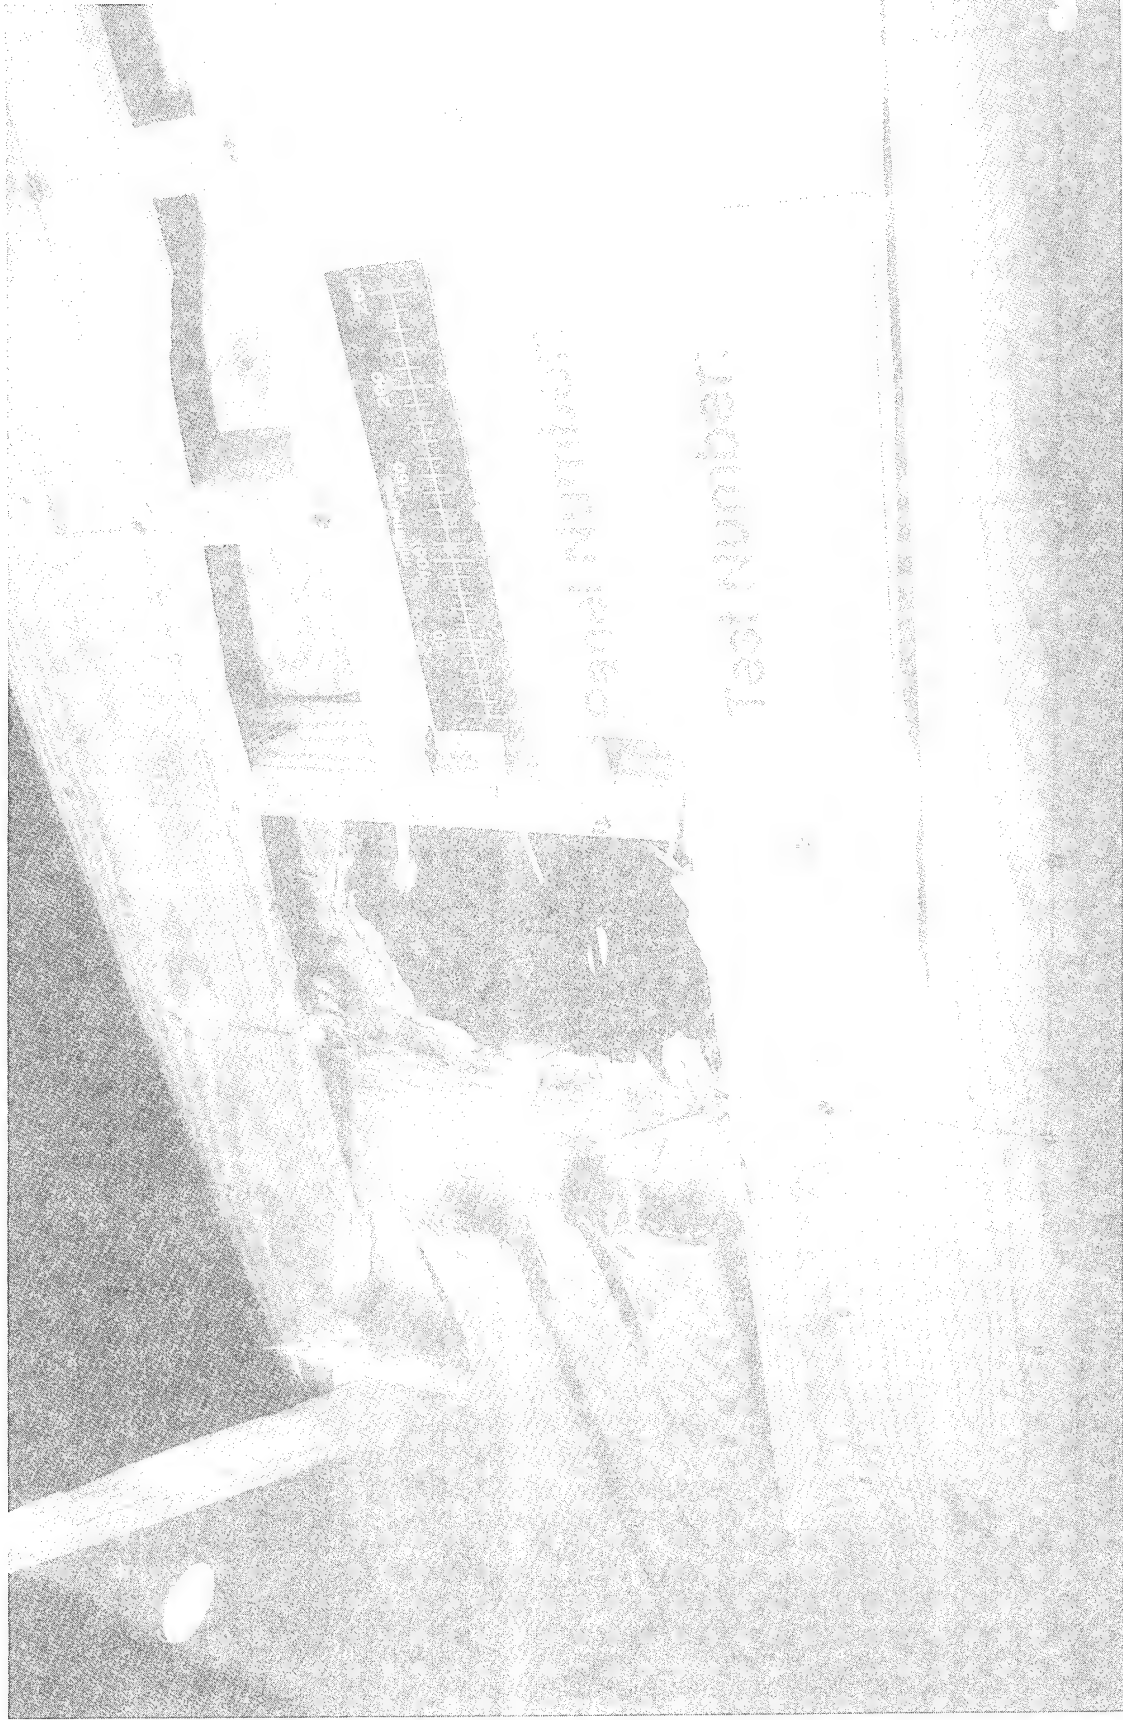
Figure 35. Protect side of panel XPK-05N-DOS-01 after test 1-4

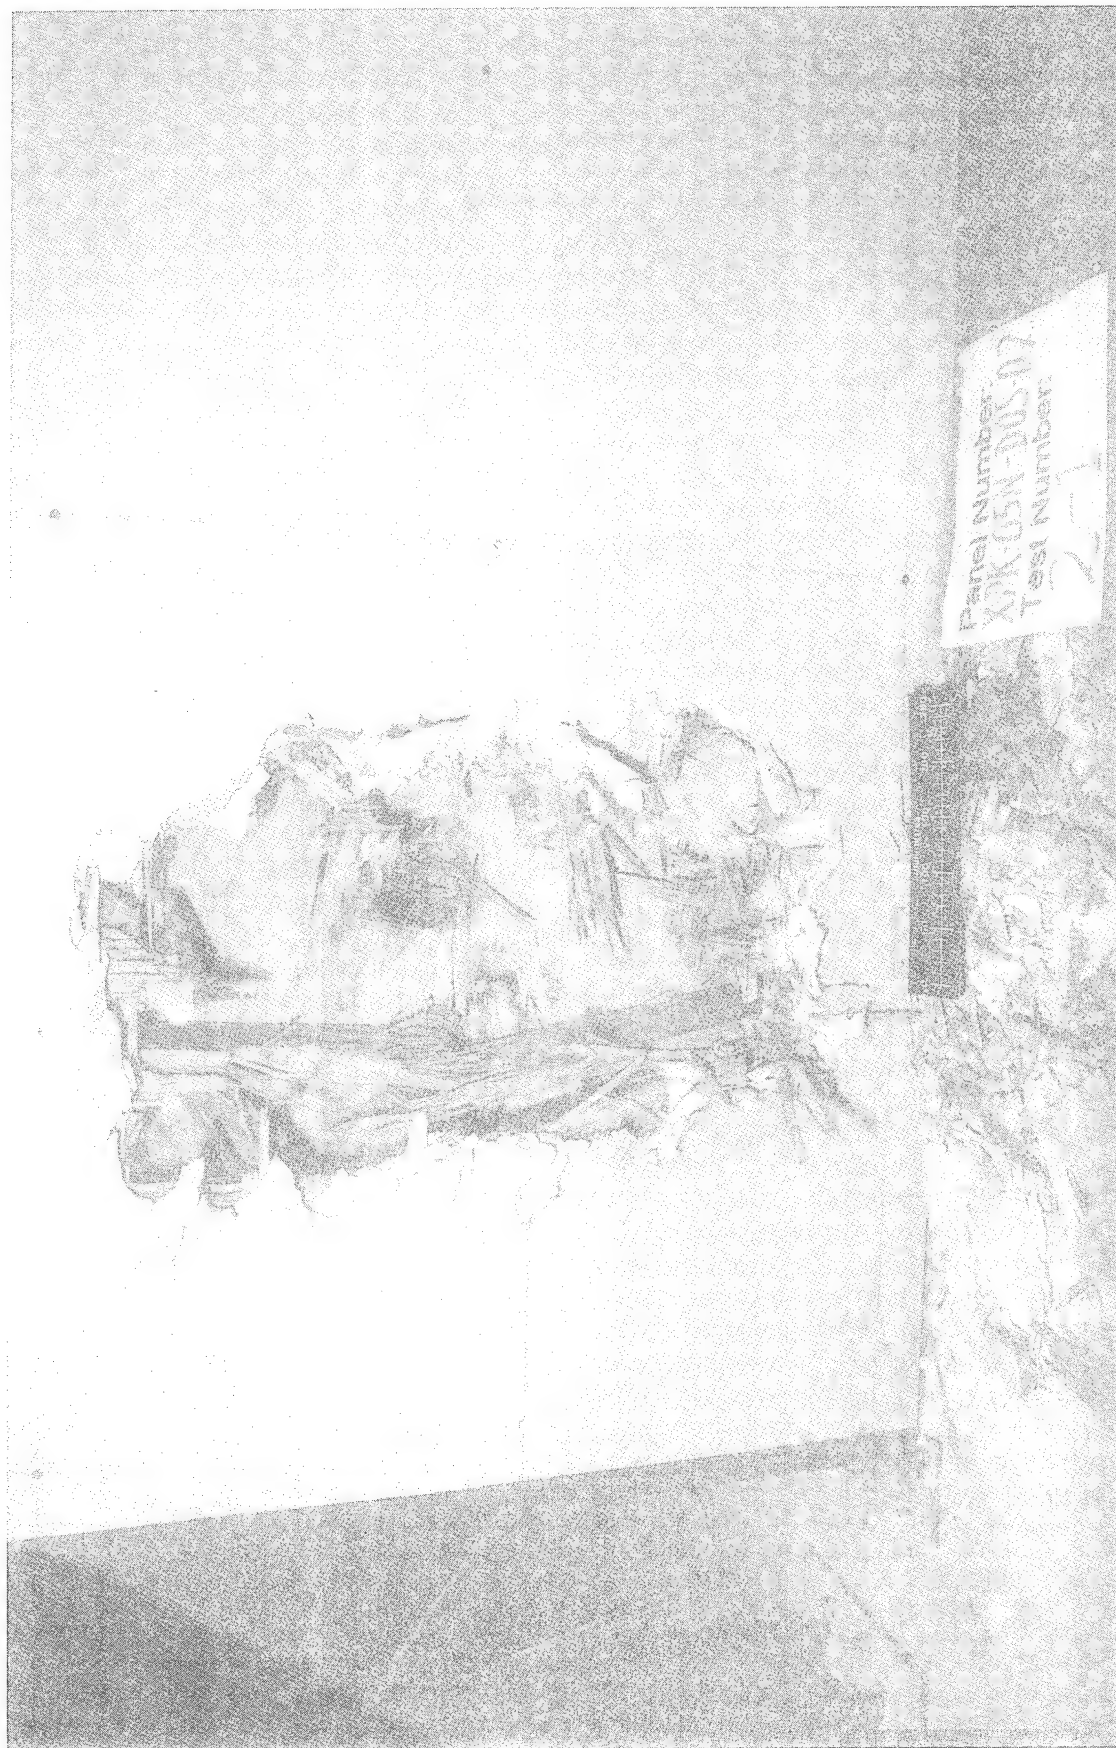
Figure 36. Assault side of panel XPK-05N-DOS-02 after test 2-1

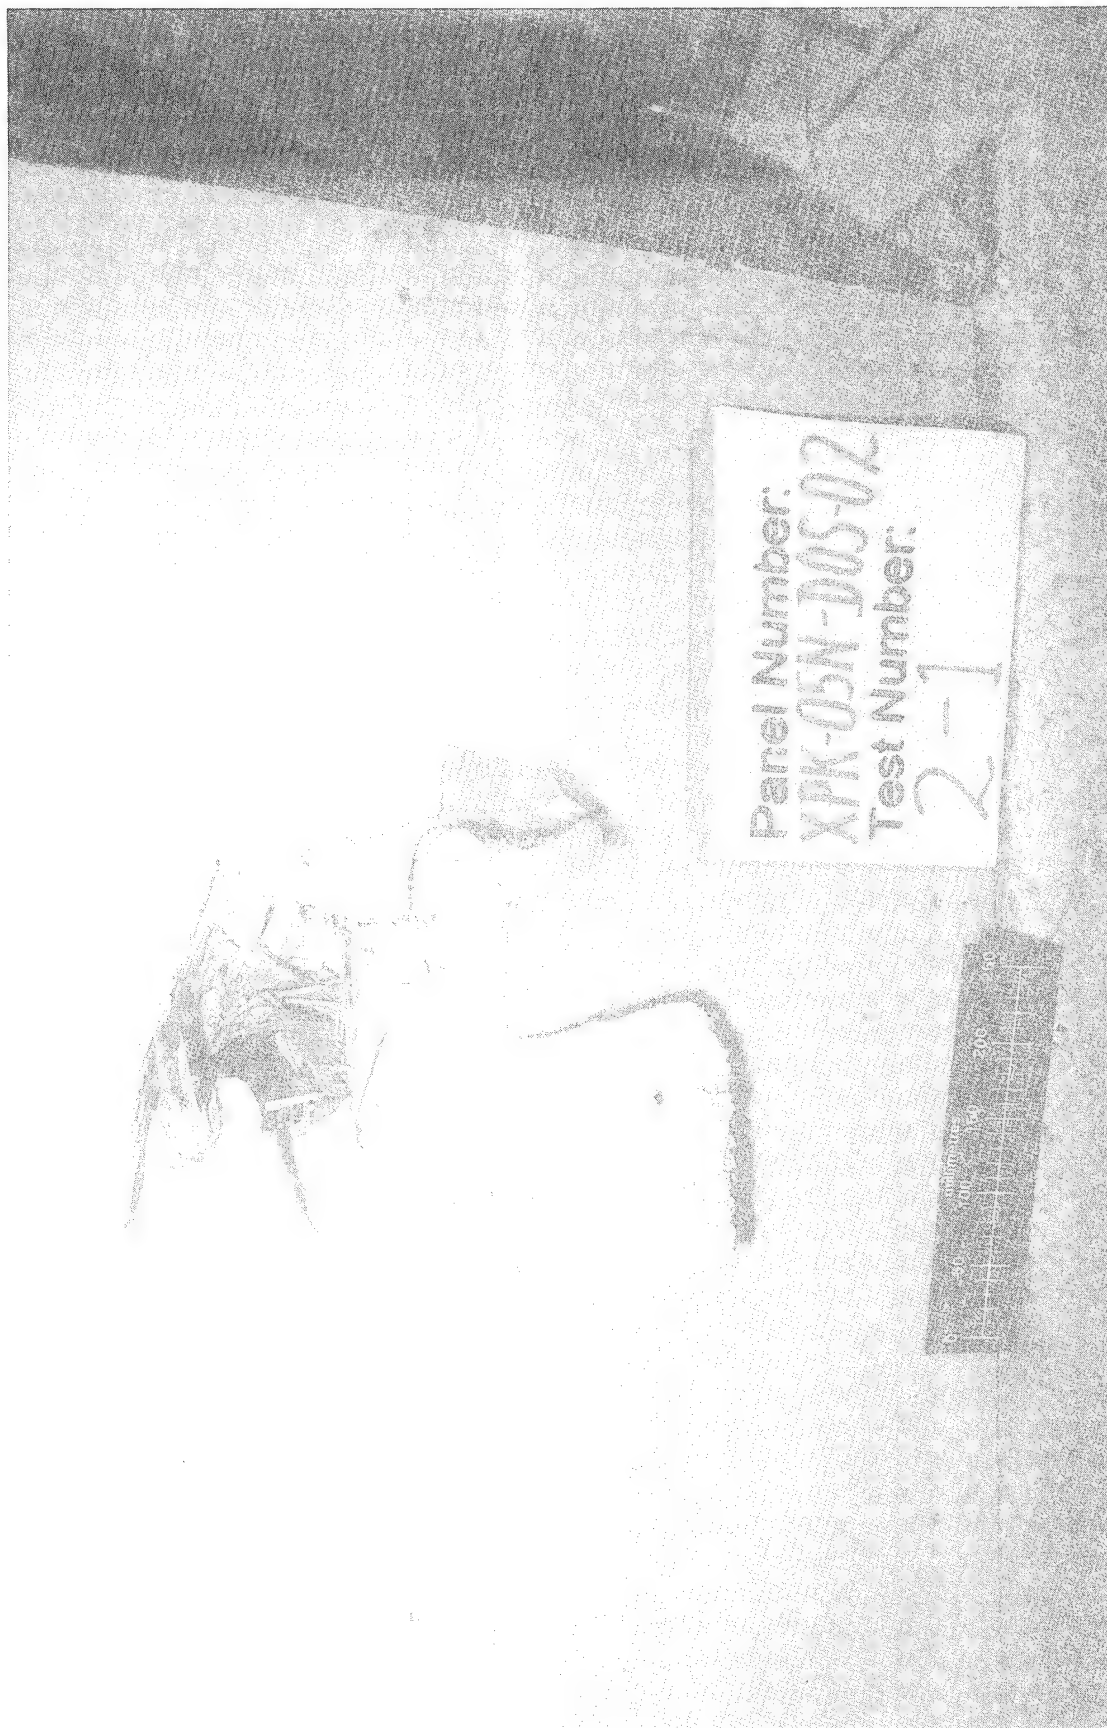
Figure 37. Protect side of panel XPK-05N-DOS-02 after test 2-1

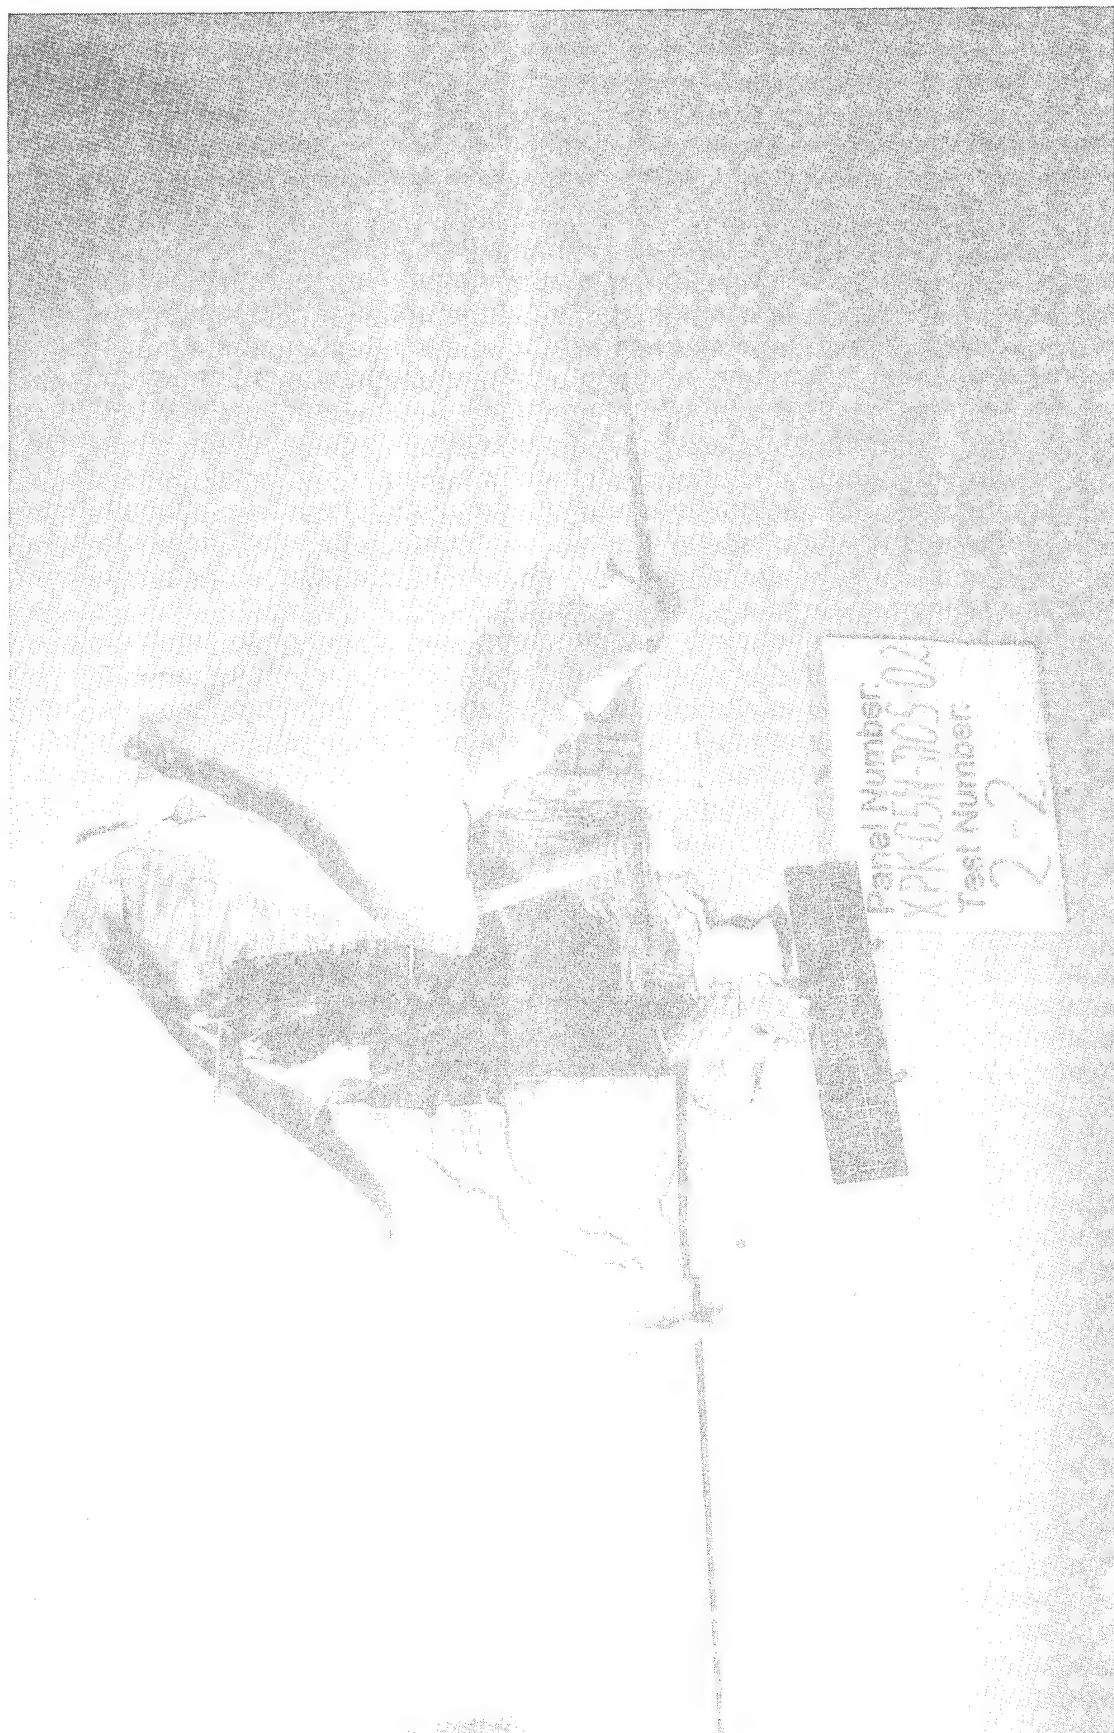
Figure 39. Protect side of panel XPK-05N-DOS-02 after test 2-2

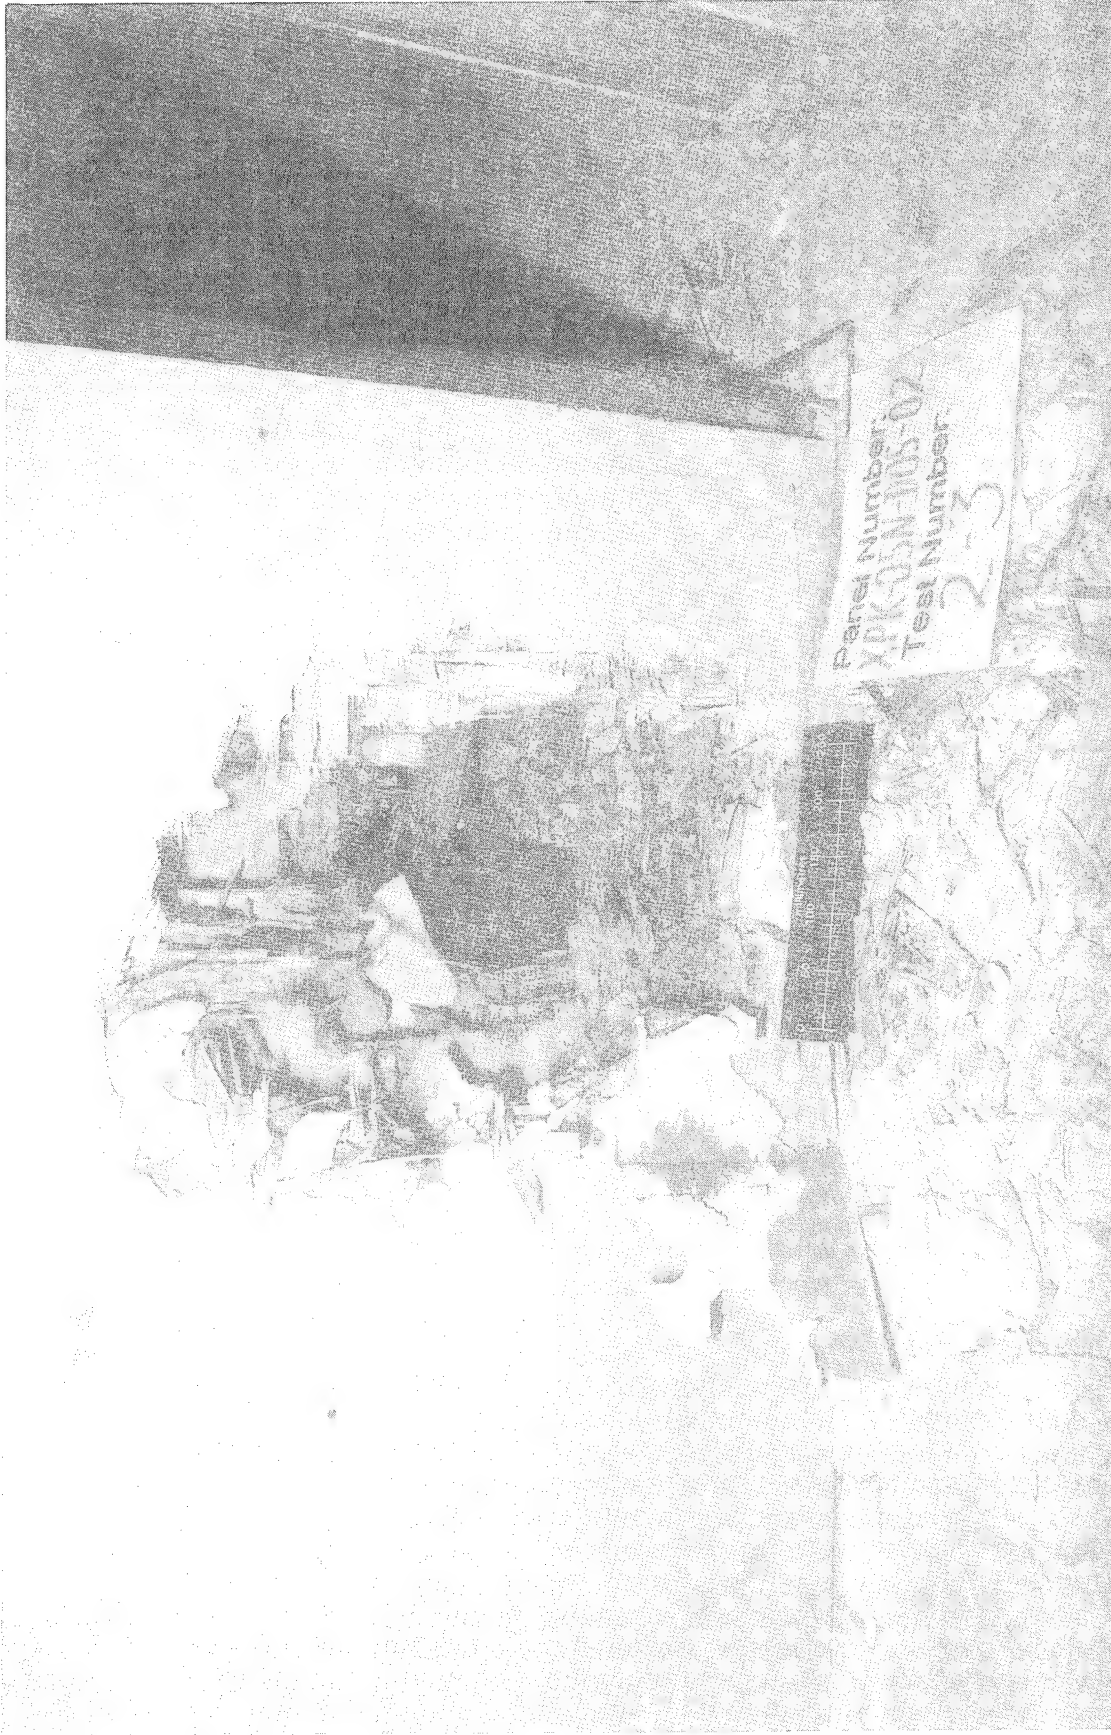
Figure 40. Assault side of panel XPK-05N-DOS-02 after test 2-3

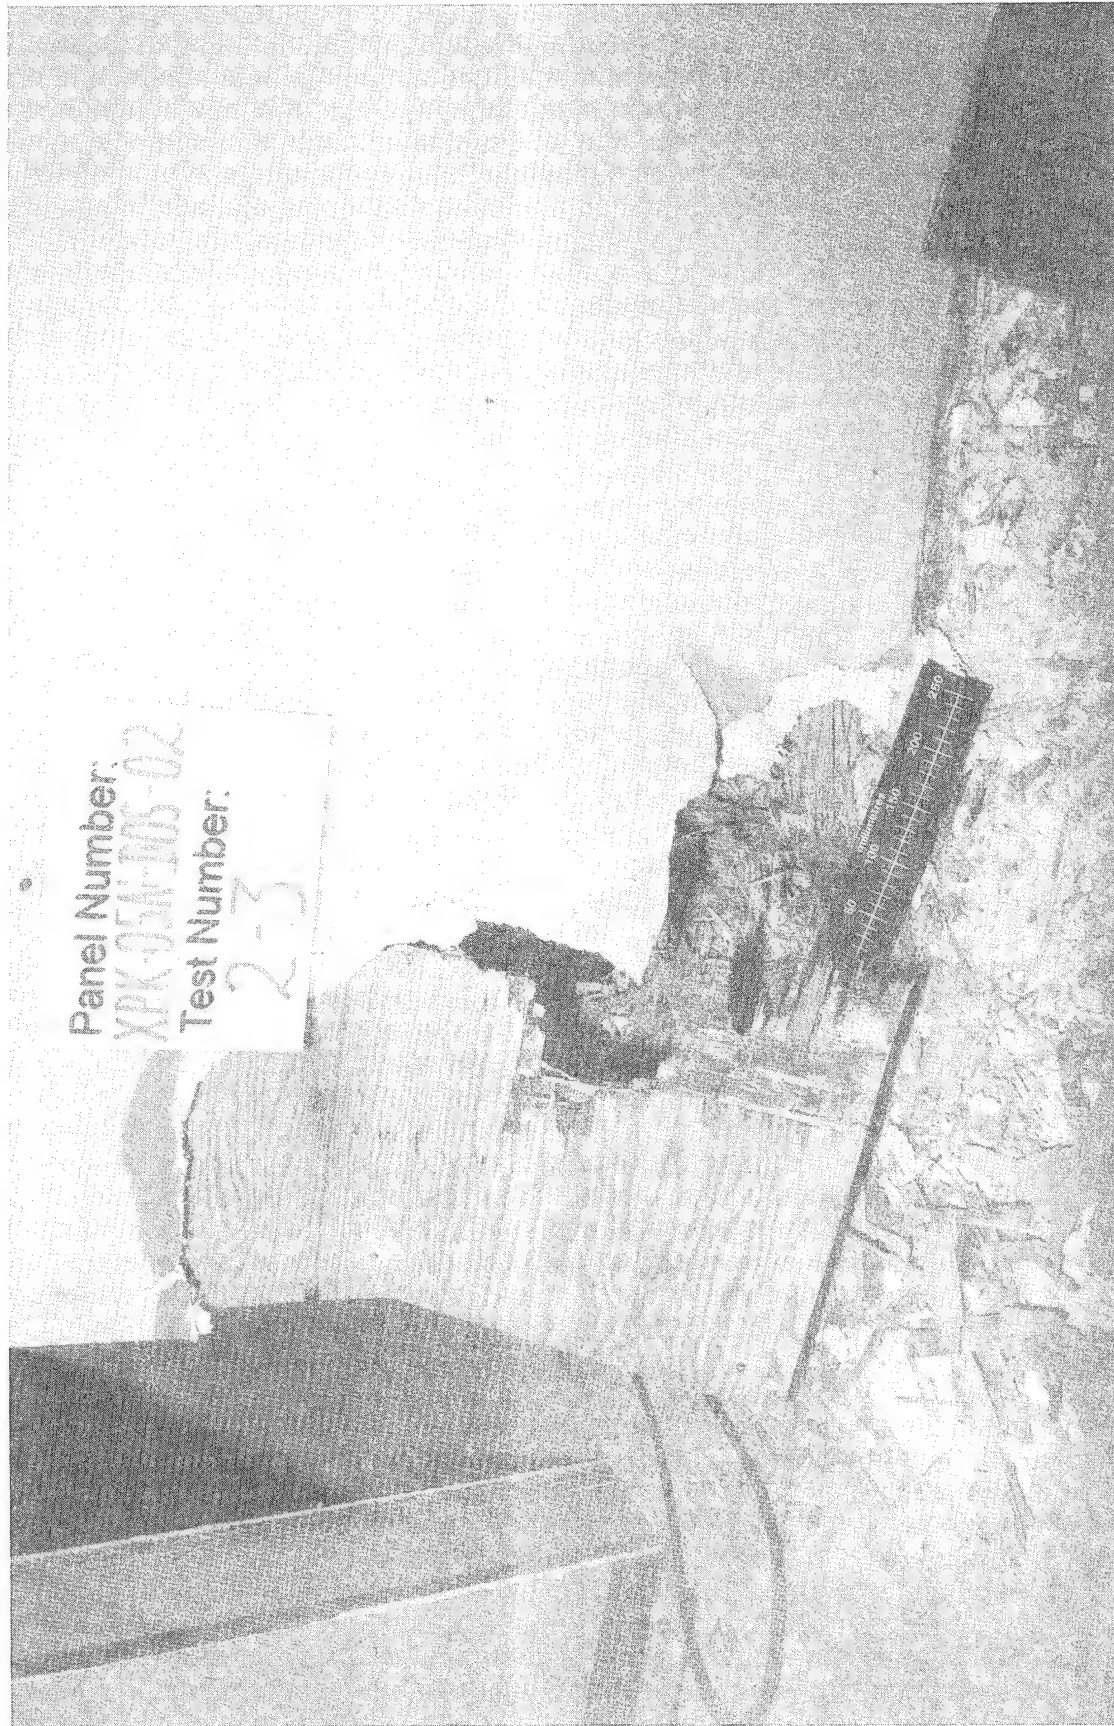
Figure 41. Protect side of panel XPK-05N-DOS-02 after test 2-3
